MGB ELECTRICAL SYSTEMS – THE ESSENTIAL MANUAL

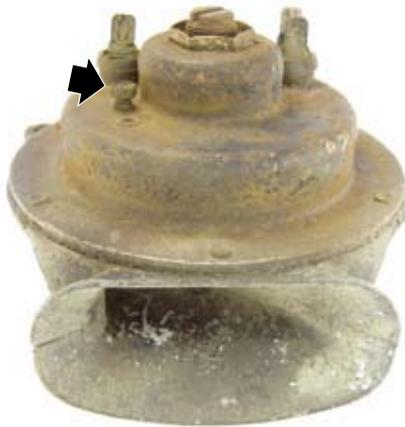
Figure 17.2. A typical pre-1975 horn. The adjustment screw is arrowed.

The horn in Figure 17.2 was one of a pair that exhibited poor volume. The author works in the automotive industry and was able to have them examined at the laboratories of the largest horn producing company in the world. This company can tune horns in a special
